THE LAST SECONDS OF FLIGHT OF THE TU-154M IN SMOLENSK ON 10TH OF APRIL 2010

Glenn Arthur Jørgensen

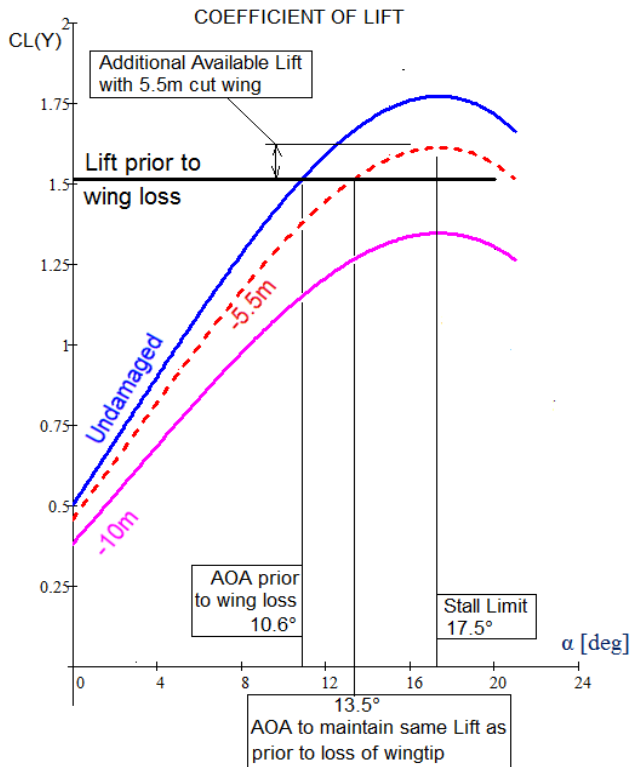
Fig. 1. The overall lifting coefficient Cl versus the angle of attack for the undamaged wing (blue solid line), a wing with a loss of $\Delta L = 5.5\text{m}$ (red dashed line) and a wing with loss of $\Delta L = 10\text{m}$ (magenta solid line).

By Fig. 1 it is seen, that a lifting coefficient of $Cl = 1.516$ is obtained for $\alpha = 10.6^\circ$ for the undamaged wing and for $\alpha = 13.5^\circ$ for the case of a loss of a wing span of $\Delta L = 5.5\text{m}$.

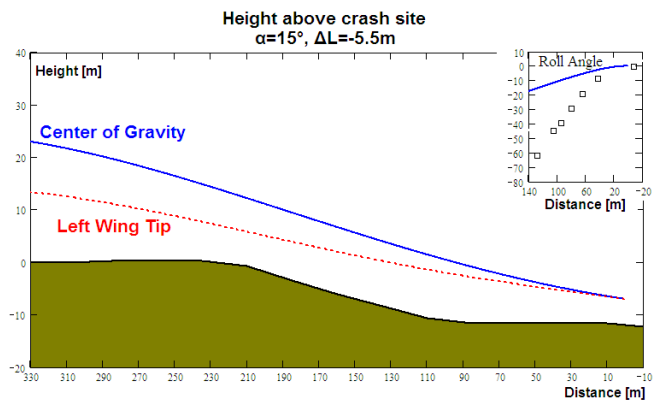
say $G = 1.25$ [5]. In this case they would be able to climb about 38m between the birch tree and crash site and they could keep the planes roll angle between 20° to 30° , as shown in Fig. 2 depending on how quickly they react.

Fig. 2. The calculated trajectory of the planes center of gravity (blue line) and left wing tip (red dotted line) for the case of a wing loss of $\Delta L = 5.5\text{m}$ at 5m height above the ground of the birch tree as assumed by the official Russian story. Here with the use of the right aileron/outer interceptor. The effect of the immediate vertical velocity change of $\Delta V_z = -2\text{m/s}$ as found in equation (6) is included. The plane is flying from right to left. The green area represents the ground height as by [5]. The small inserted box shows the resulting roll angle of the plane (blue line) together with the recorded roll angle (black squares). Note the plane would roll moderately and climb well above the crash site with a loss of the wing tip only. Note the roll angle of the plane after 140m flight (see inserted box in upper right corner) corresponds well with the recorded plane roll by the QAR black box (roll = 17°) as shown in Fig. 3.

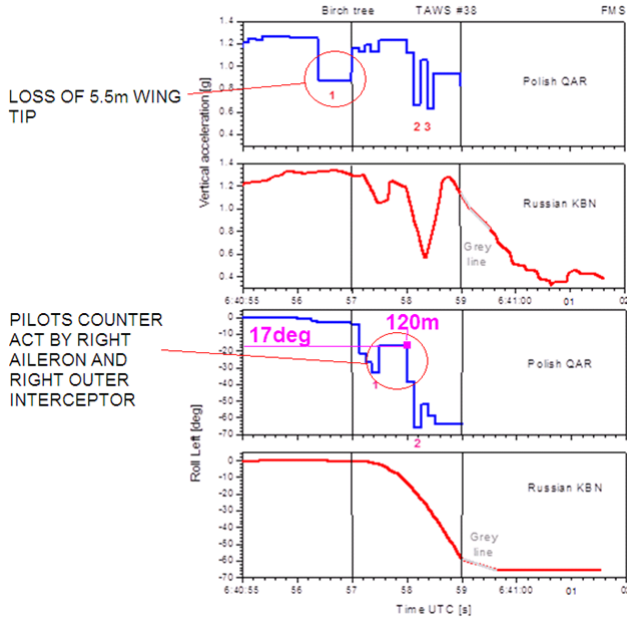
where ΔG_1 is the sudden drop in vertical acceleration, and ΔT the time this occurs. For a drop of say $\Delta G_1 = 0.367$ over at time say $\Delta T_1 = 0.6\text{s}$ (see Fig. 3) one gets

Fig. 3. From the top is shown the vertical acceleration by the Polish QAR, then the same by the Russian KBN. Next two plots show the left roll angle by the Polish QAR then the same by the Russian KBN. Event 1 corresponds to the loss of the wing tip and event (2, 3) the loss of the additional effective 4.5 m of the left wing. The distance from first drop in the vertical acceleration signal to the second event is approximately 120 m by the QAR data and about 47m by the Russian KBN data. The roll of the plane 120m after loosing the wing tip can be seen as $\phi = -17^\circ$ by the black box data. This agrees well with the calculated value shown in fig. 2 Original figure by Prof. Kazimierz Nowaczyk.

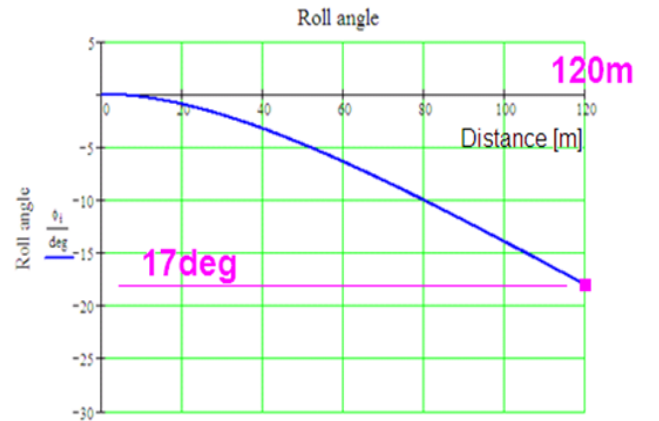
Fig. 4. The calculated roll angle as a function of distance in the event the reaction time of $\Delta T = 0.3$ s to achieve the full right aileron and full right outer interceptor between the two wing losses. This takes into account the human reaction time and the system latency. The roll angle in this case is found to be $\phi = -17^\circ$ at a distance 120 m from the loss of the wing tip. This corresponds very well with the value recorded by the QAR black box as shown in Fig. 3.

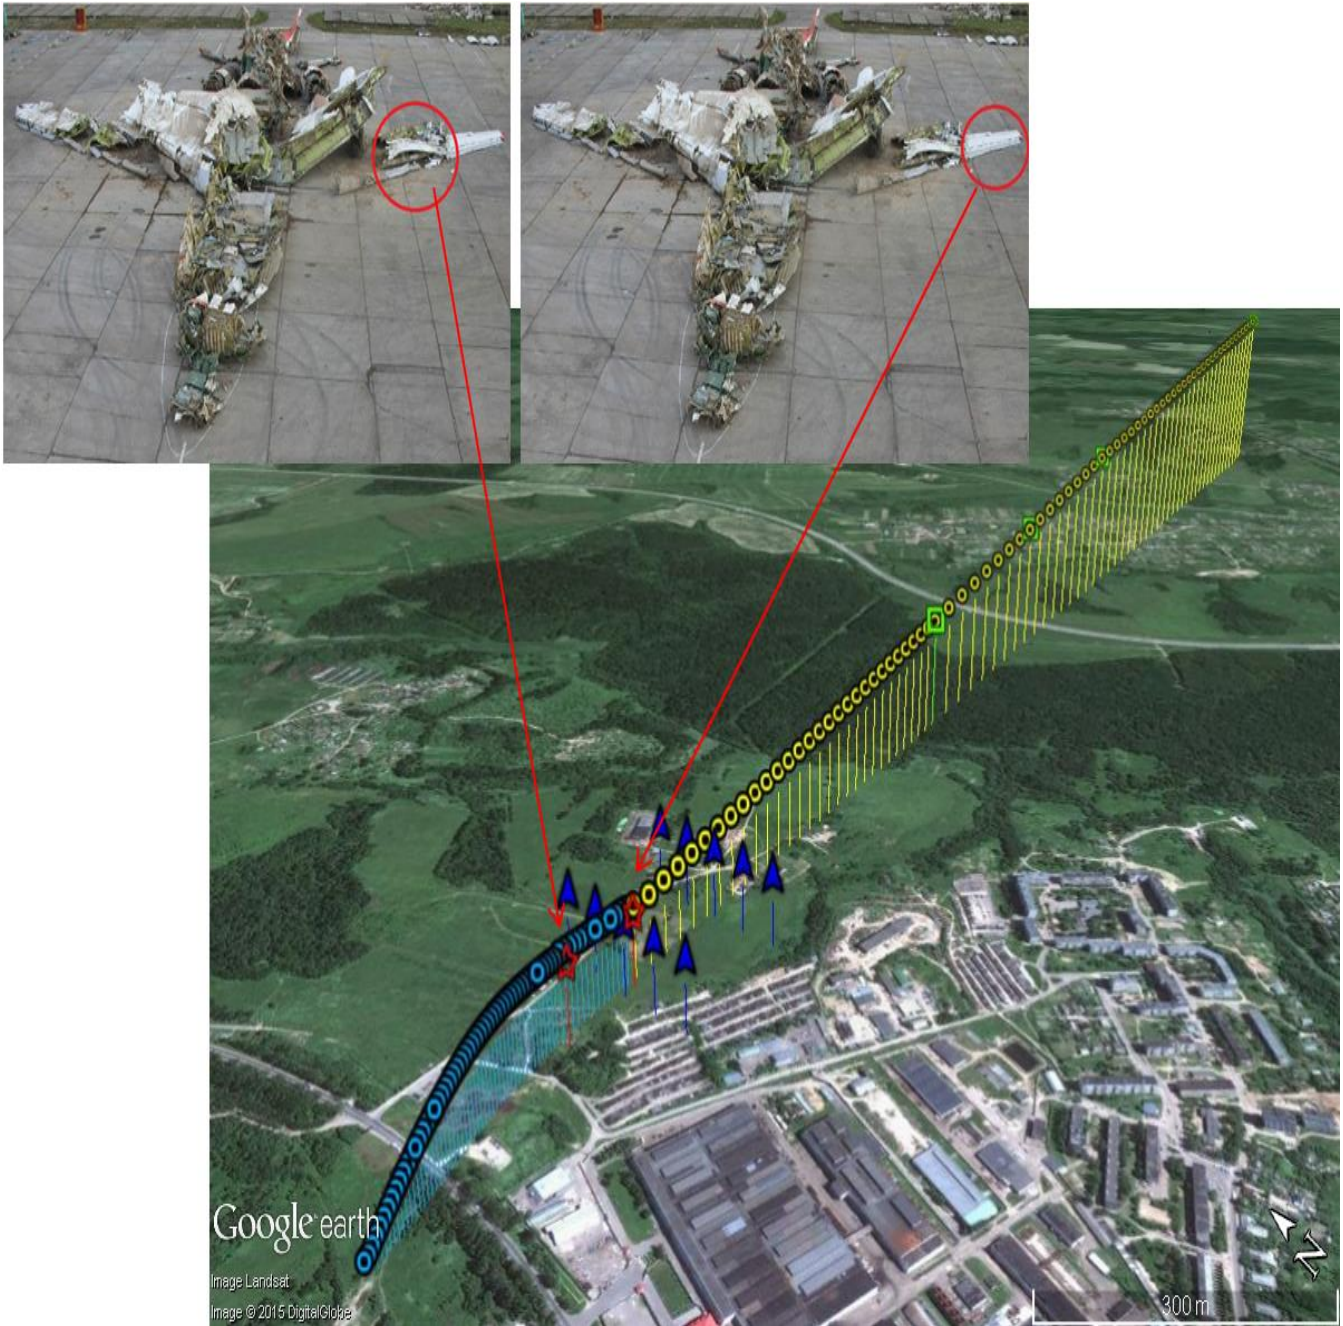
Fig. 5. The green squares show the logged GPS heights [8, 9] and positions of the TAWS 34 to TAWS 37 events [8, 9], and the blue triangles show the trajectory line between these together with the trajectory of go-around within the middle marker zone (blue circles). Working back from the crash site by the aerodynamics brings the trajectory of the center of gravity (blue circles) to the exact position of the GPS trajectory. According to the official Russian explanation the pilots called they would do "go-around" at $T=10:40:50.5$. The calculated height above runway 26 at this point is $H=95m$ to $H=100m$. This confirms the calculations, as $H=100m$ is the official decision height during this approach. With other words this is the lowest height, where the pilots must make their decision to either continue the approach or perform a go-around depending on wether they have correct visual sight of the runway or not. By the official explanation it is known, that the pilots did not have the required visual sight of the runway, and it is therefore a logic consequence of this, that they called the go-around at this height. The data and calculations clearly support this. The red stars show the two positions where the wing explosions occurred, and the upper figures show which wing sections are lost. The second explosion mainly removes the top part of the middle wing section by creating a center hole. During the remaining flight this part of the wing continues to break up as a result of the aerodynamic forces. The bottom part of the middle section with the Polish emblem is most likely torn off during the first wing ground contact. Following the two wing explosions a third explosion emptying the center fuel tanks took place at the position of the TAWS 38, and was probably the cause of the false interpretation by the control system that the plane had landed

Fig. 5 shows how the calculated trajectory based on the aero dynamics and the CFD input perfectly meet the trajectory made by a line passing through the recorded GPS heights and positions including a go-around manuvre as recorded by the vertical acceleration sensor. Also the calculated vertical speed towards the ground is in agreement with the recorded 22.2 m/s at the position of the final FMS recording 60 m before the point of wing ground contact. With other words *the pilots never made the very strange steep dive to the ground 2-3 km before runway 26 as claimed by the Russians.* They did not approach terrain with 23 m/s when at 65 m above the ground as stated in the MAK report. Such dive makes no sense what so ever, even

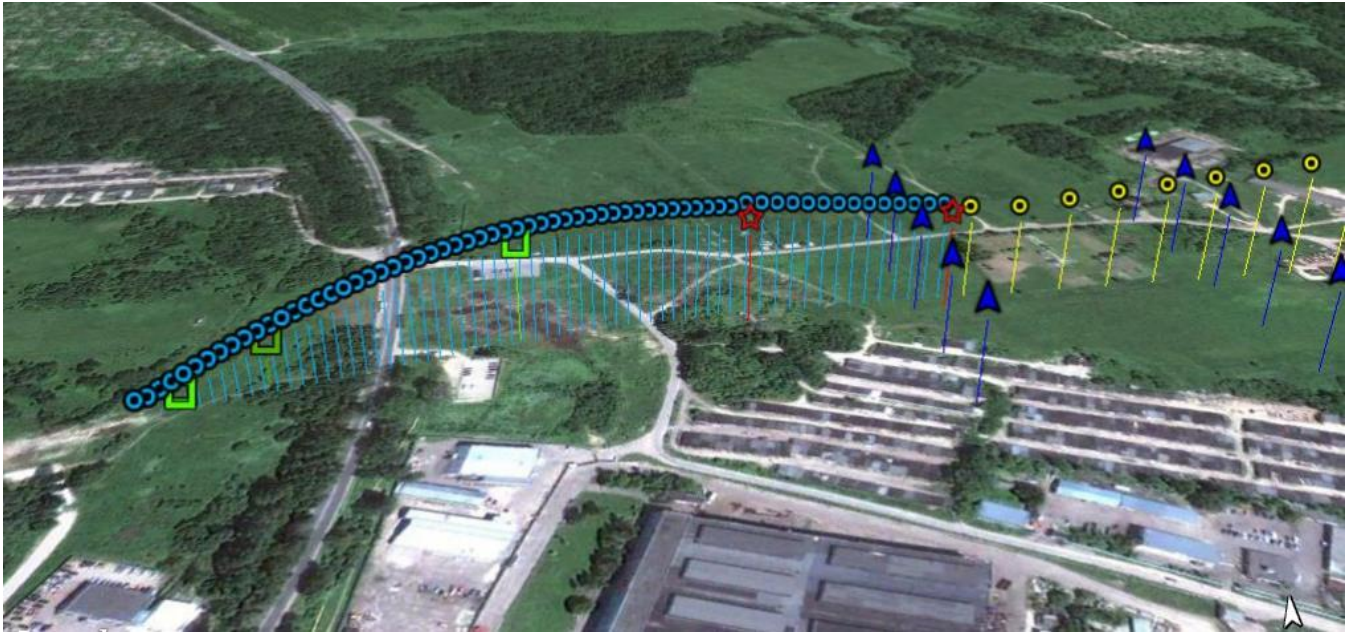
Fig. 6. The loss of the wing tip occurs during pulling up in the go-around just prior to exiting the middle marker zone shown between the blue triangles at a height of about 55 m. The height entering the middle marker zone is about 75 m. The calculated trajectory of the center of gravity of the plane agrees reasonably with the logged GPS height of the TAWS 38 (the calculated height is slightly higher than the logged) and fits well with the baro corrected height and GPS position stored by the FMS (green squares). The velocity towards the ground at this point is recorded as $V_z=22.2$ m/s and agrees very well with the calculated $V_z=23$ m/s.

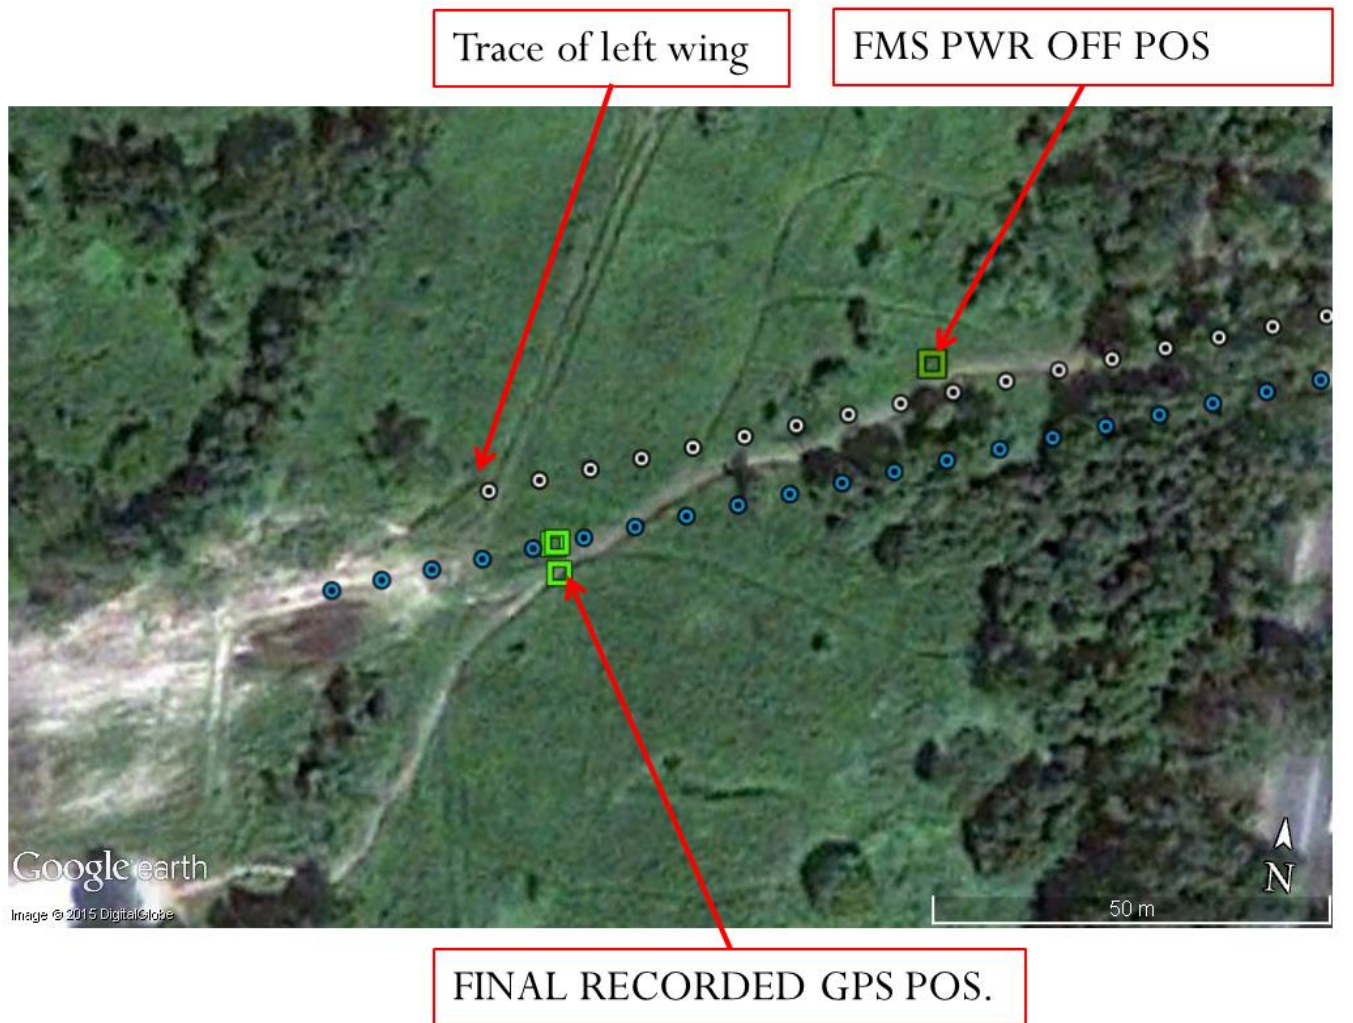
Fig. 7. The calculated trajectory of the center of gravity (COG) of the plane (blue circles) and the calculated trajectory of the left wing (white circles). Note how the wing trajectory ends at the position of the wing ground trace, and how the COG trajectory ends at the correct location passing through the final recorded three independent GPS positions. Note also how the heading is in well agreement with the direction of the ground scratches.

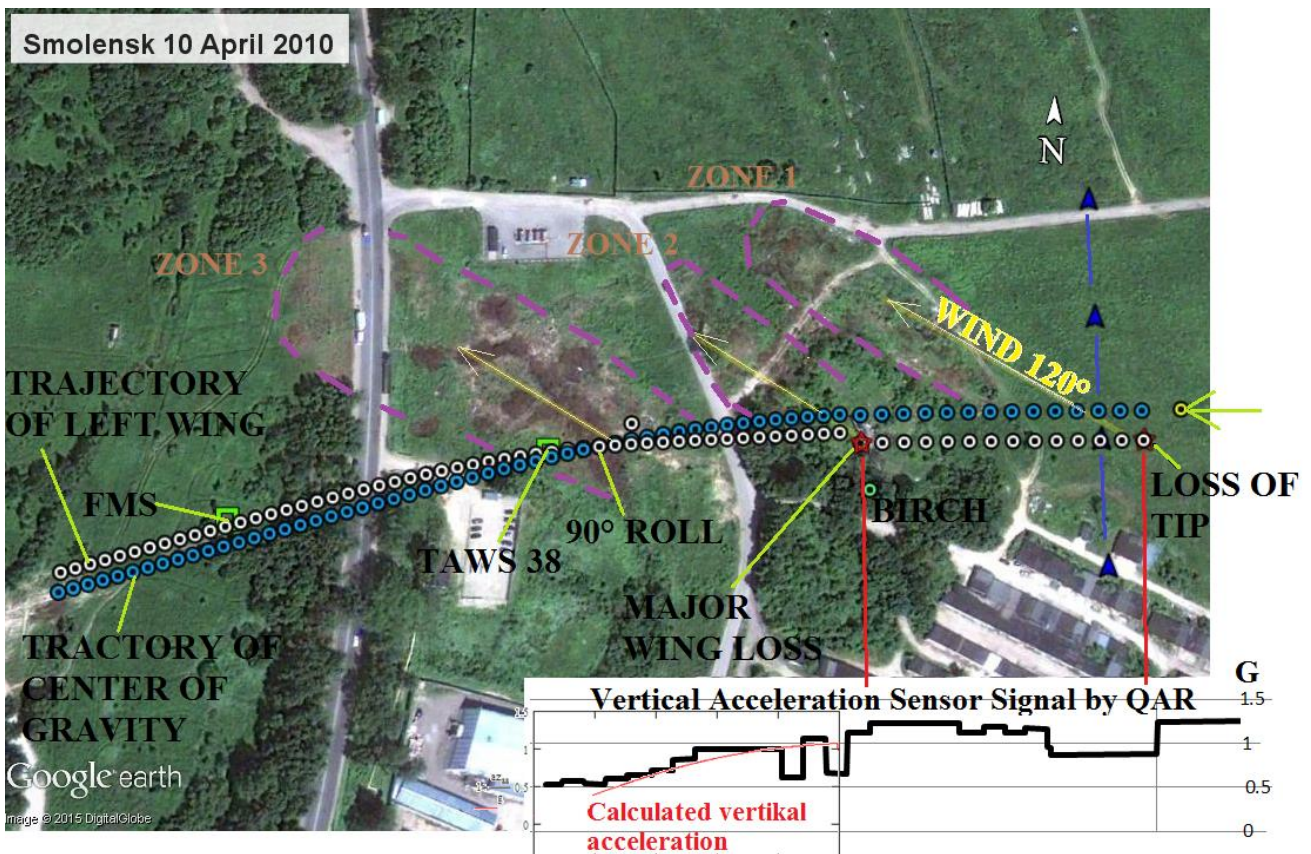
Fig. 8. The calculated trajectory for the center of gravity (blue) and the left wing tip (white). The satellite picture is from the 25th of June 2010 (two months after the crash). Notice the distinct and significant damage of vegetation in the three areas (zone 1, zone 2 and zone 3) circled by the dashed lines. Adding the recorded vertical acceleration signal by the Polish QAR (black line) and the wind direction of 120° show the clear correlation between the three distinct areas of vegetation damage to the approximate positions of the loss of the wing tip, loss of additional wing area and a third explosion emptying the center fuel tanks and triggering the TAWS 38 recording. In agreement with the location of the damaged vegetation patterns the loss of the wing tip took place 100m - 120 m earlier than the birch tree just before or after the exit of the middle marker zone (blue triangles). The distance between the patterns corresponds to the flying distance between the two events (loss of wing lift) as recorded by the Polish QAR black box. The final calculated velocity ($V_z = 23$ m/s) towards the ground at the "FMS" point agrees well with the recorded value of $V_z = 22.2$ m/s. The scenario can also explain why wing parts are found earlier than the birch tree and in a belt along the highway north of the trajectory. The calculated vertical acceleration (red line of bottom fig.) shows same characteristic decline as the recorded signal..

The damaged vegetation (see zone 1 and zone 2 of Fig. 8 fits with fuel/hydraulic oil poisoning of the vegetation by the fuel and hydraulic oil dispersed from the planes wing at each wing loss and carried by the 120° wind. The third and largest zone (zone 3 of Fig. 8) of damaged vegetation occurred down wind from the region the planes roll angle passed through 90° at the position of TAWS 38.

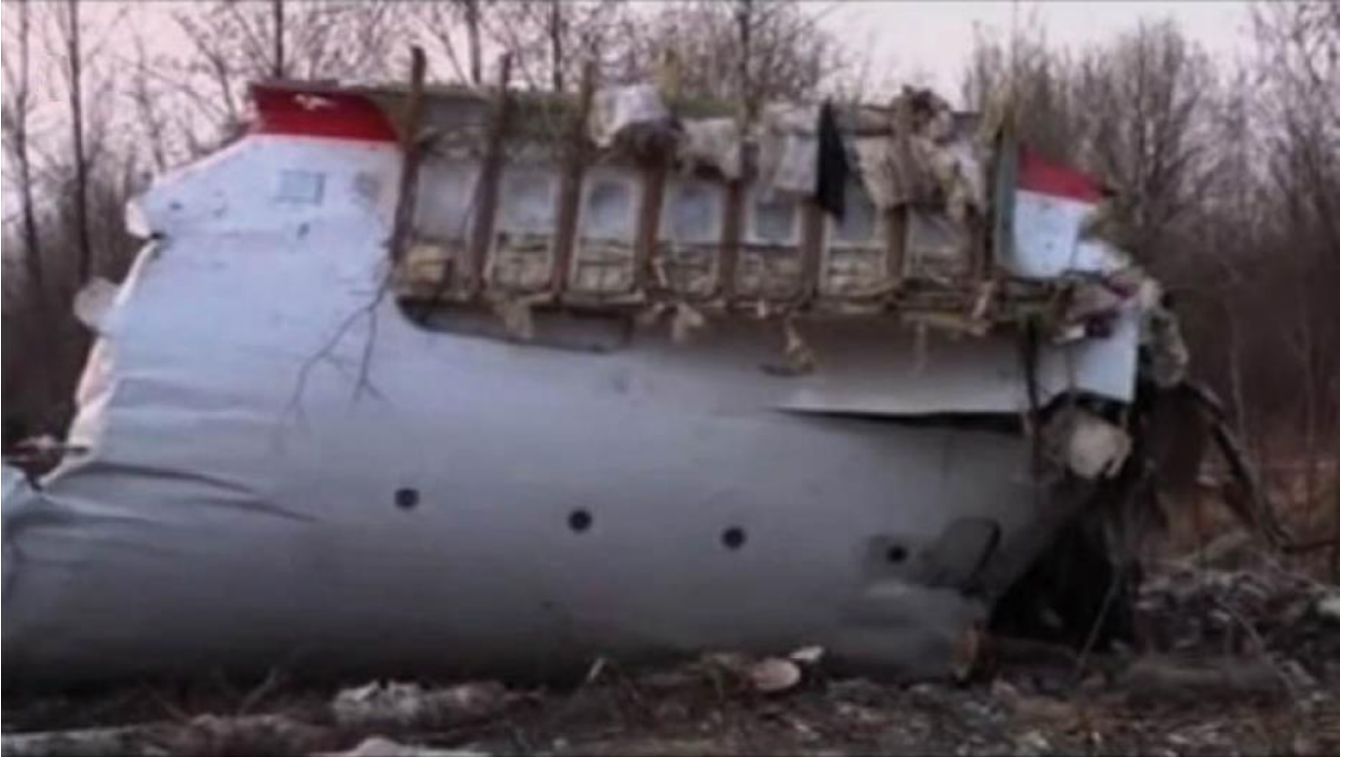
Fig. 9. The front bottom section below the president's salon. The entire top section is pulverized and the window section was thrown outwards most likely caused by the high internal pressure at the near ground explosion. Note the windows have not been in ground contact.

This indicates the tail structure was separated from the rest of the fuselage structure while the gyro moment was acting. The front bottom section below the president's salon is shown in Fig. 9. The entire top section is pulverized and

missing. The window section was thrown outwards like caused by a high internal pressure at the near ground explosion. The windows show no sign of being in ground

contact, which excludes the possibility of the top side of the fuselage being damaged and torn during the ground contact itself.

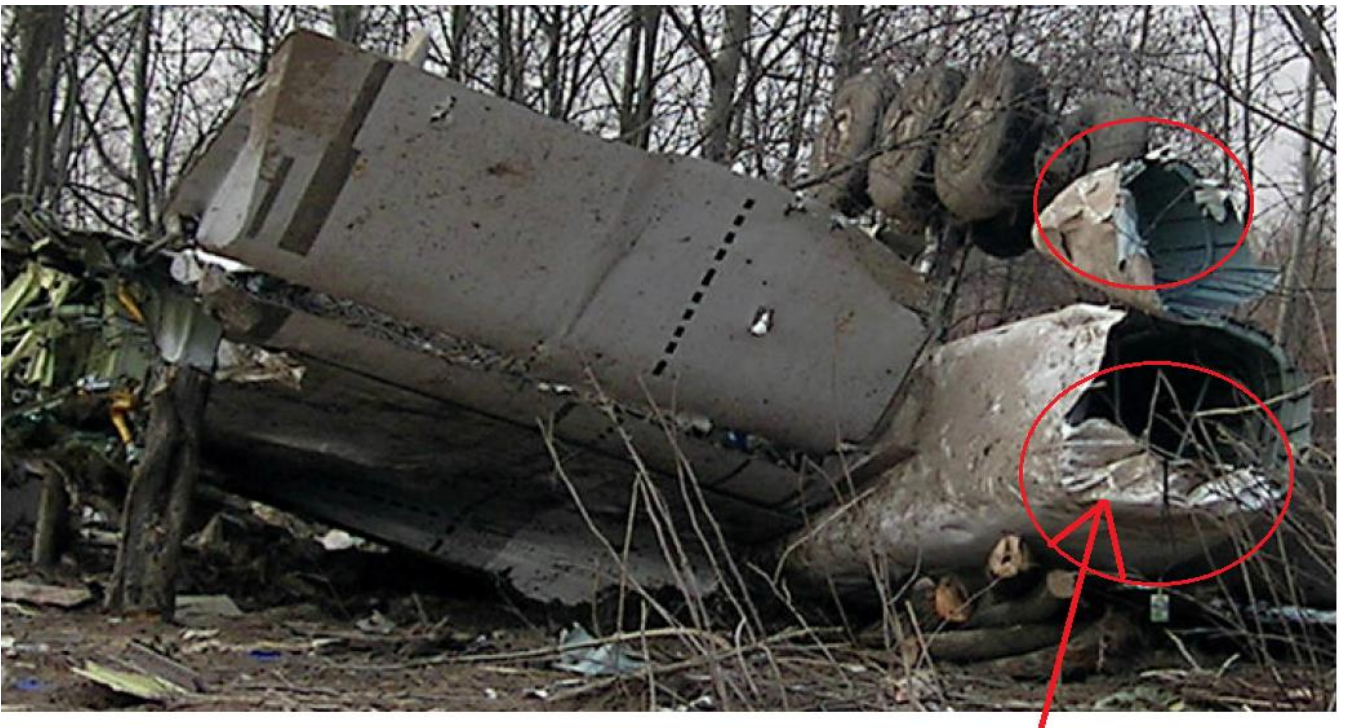
OBSTACLE HAS HIT FROM THIS SIDE

Fig. 10. The left wing root shortly after the crash. The portion shown in the pictures left side was originally facing towards the fuselage. Notice the wheels are soiled on the inwards side of both rows, but not along the entire rim, only at the small portion of the rim, that was facing downwards during the sideways sliding/turning movement of the wing piece. Also notice the end of the wheel house shows indication of being hit by an object (most likely a tree) from the wings topside during the roll movement described below

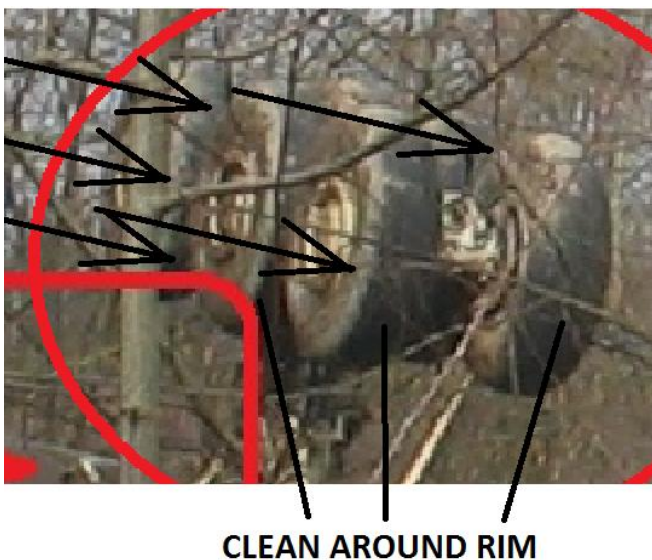
Fig. 11. The *inwards* side of the both rows of the left wheels is soiled, whereas the rims themselves are clean. Had the wheels been downwards in a normal landing position and making contact with the soft ground at the crash site, the rims should be covered with mud all around.

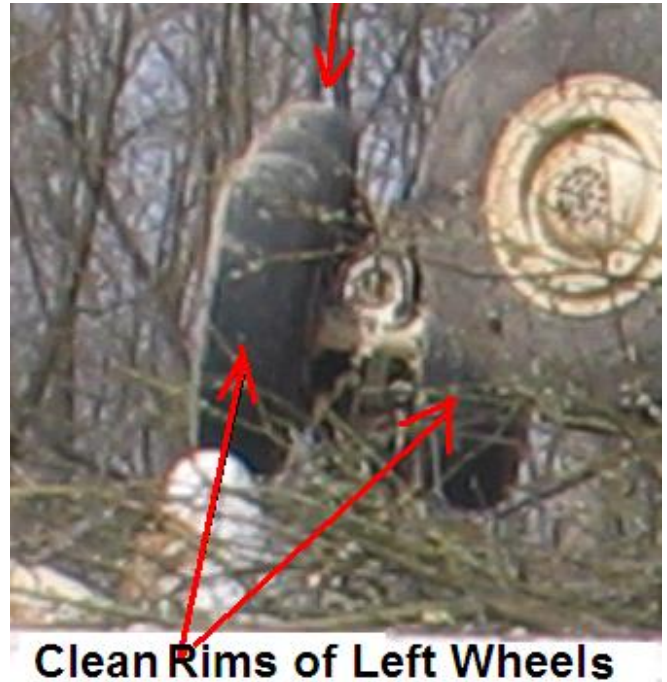
Fig. 12. Same as Fig. 11.

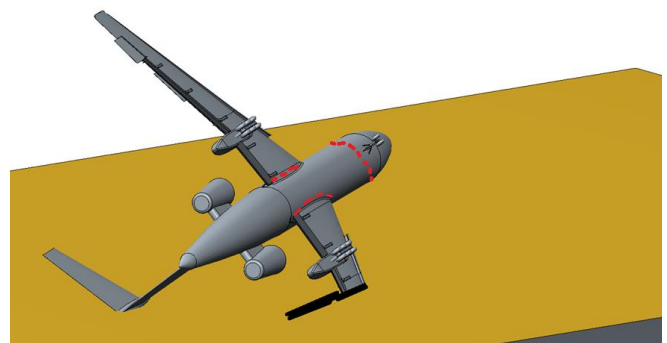
Fig. 13. The plane making its first ground contact with the left wing tip and tail. The planes orientation is found both by the aero dynamical work and independently confirmed by the ground trace analysis [3]. As the left wing tip is in contact with the ground the downwards movement of the fuselage will result in an anti clockwise rotation of the left root part.

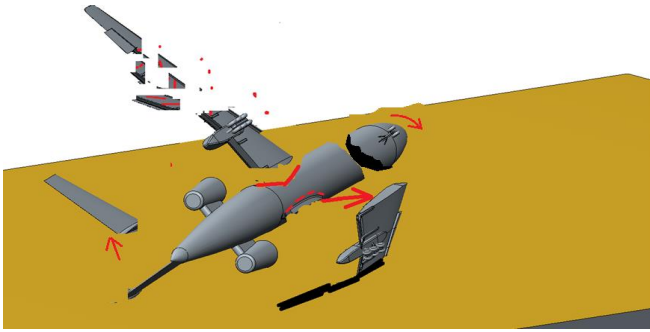
Fig. 14. Based on the length of the ground trace the first main fuselage explosion occurred 0.3 s after the initial ground contact. From this point all ground traces suddenly stop, and no crater is formed even though the official explanation states the 78.6 tonne plane hit the soft ground with more than 100 g, equal to 78600 tonne [5].

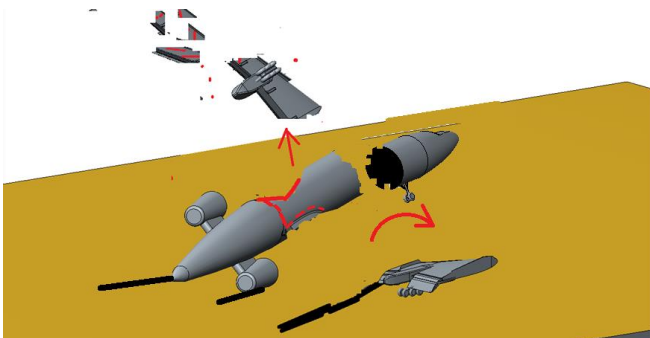
Fig. 15. When the wheels hit the ground and continued the outwards sliding movement superimposed on the initial forward velocity of the plane, the inner sides of the wheels scrapped against the ground and were soiled on this side and the inner rim portion that was downward during the slide.

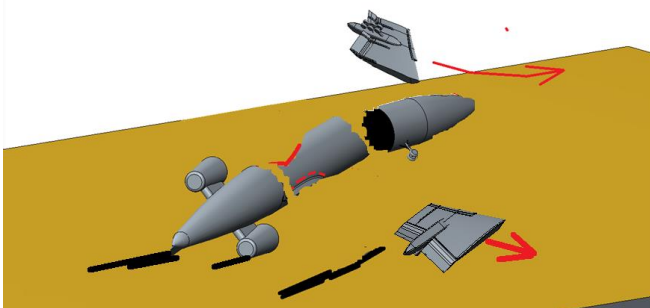
Fig. 16. The root part continues its sideways movement and rotation.

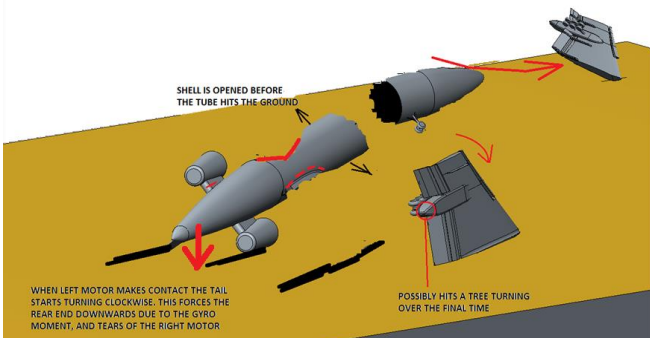
Fig. 17. During the rotation the left wheel house hits an obstacle (probably a tree) and damages the wheel house tip partly cutting this. Note the fuselage is still in free air when the explosion occurs, allowing this to open and the sides to be move outwards prior to it hitting the ground.

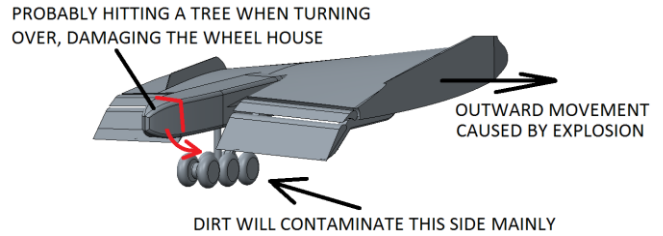
Fig. 18. The outwards sliding movement caused by the fuselage explosion will tend to contaminate the inner sides of the left wheels and the portion of the wheel rims facing downwards. The wheels show no sign of rotation during this movement.

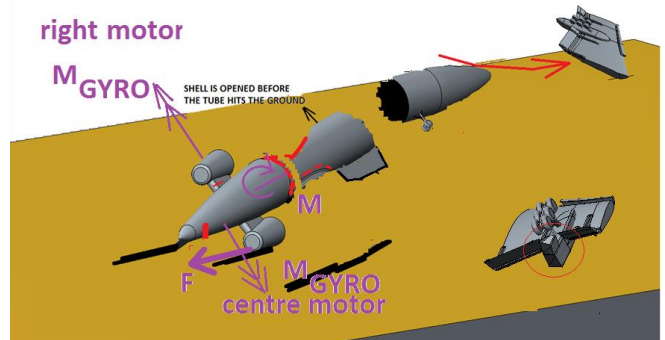
Fig. 19. The drag force imposed on the left motor as it plungers into the ground results in a turning moment M of the tail section. This causes the gyro moment of the right motor to try to twist the tail sections front part downwards, while the center motor tries to do the opposite. When the gyro moment exceeds the strength of the right motor support, the center gyro motor is allowed to quickly rotate the tail section so the front end of the tail now goes up, thereby damaging the tail rear.

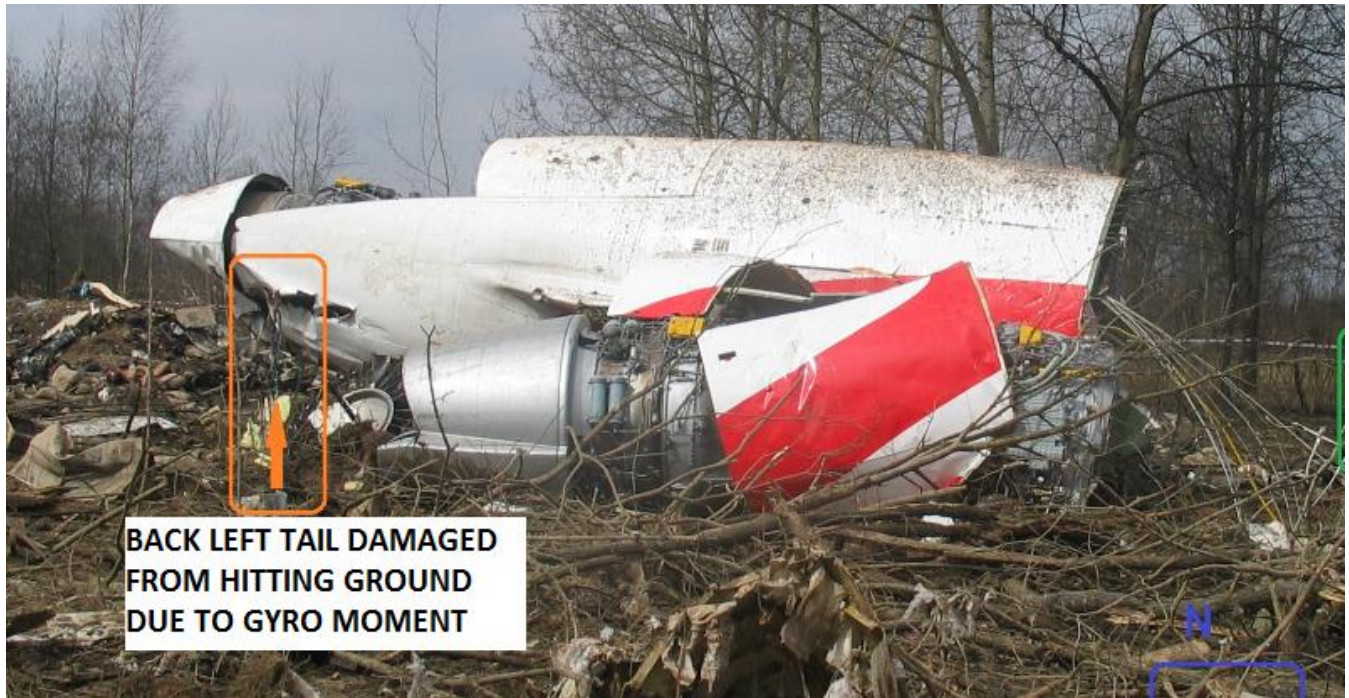
Fig. 20. The back part of the tail was damaged by the centre motors gyro moment when the right motor broke off.

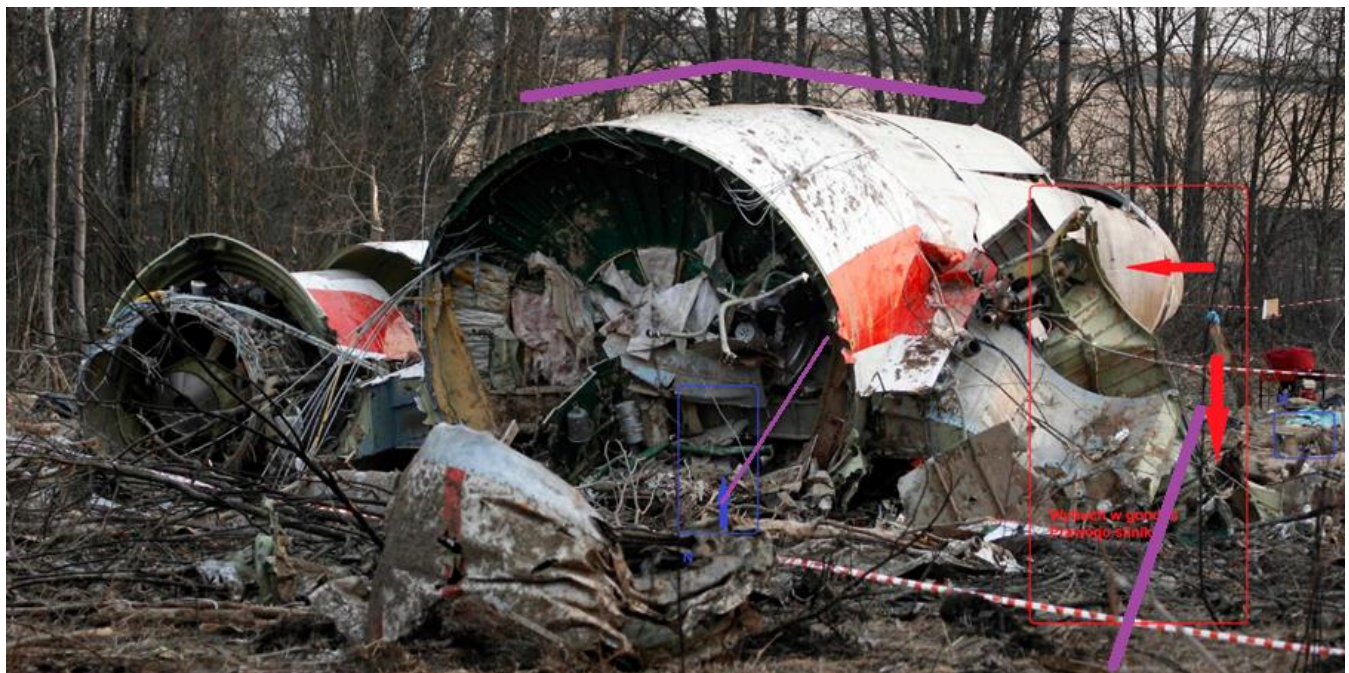
Fig. 21. The tail fuselage shows sign of the struggling between the gyro moments of the centre motor and right motor. Also notice the structure is twisted downwards inside the fuselage, indicating this structure was separated from the rest of the fuselage at the time of impact.

The twisted structure inside the tail fuselage indicates the tail was separated from the rest of the plane in air prior to the fuselage and left motor making ground contact.
